New York State Department of Transportation

Yellow Flag NB2222W011

BIN: 1065318

Location: Span 231, Girder G19 at Pier 230.

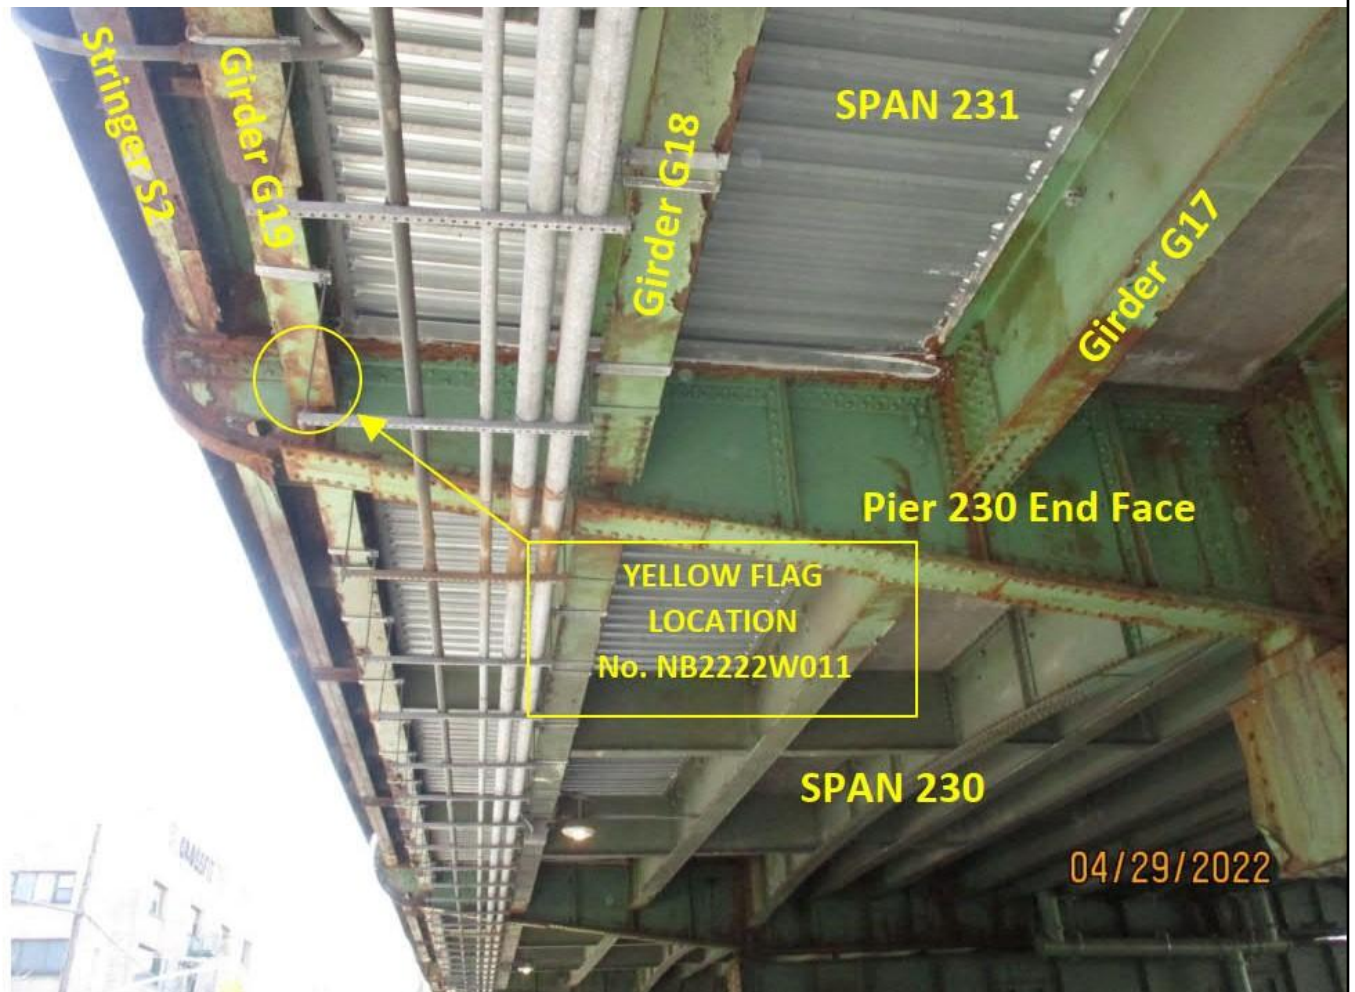
Photo Number: 1

Attachment Description: Photo 1 – Span 231, Girder G19 at Pier 230. General view of framing plan and Girder layout. Looking begin.

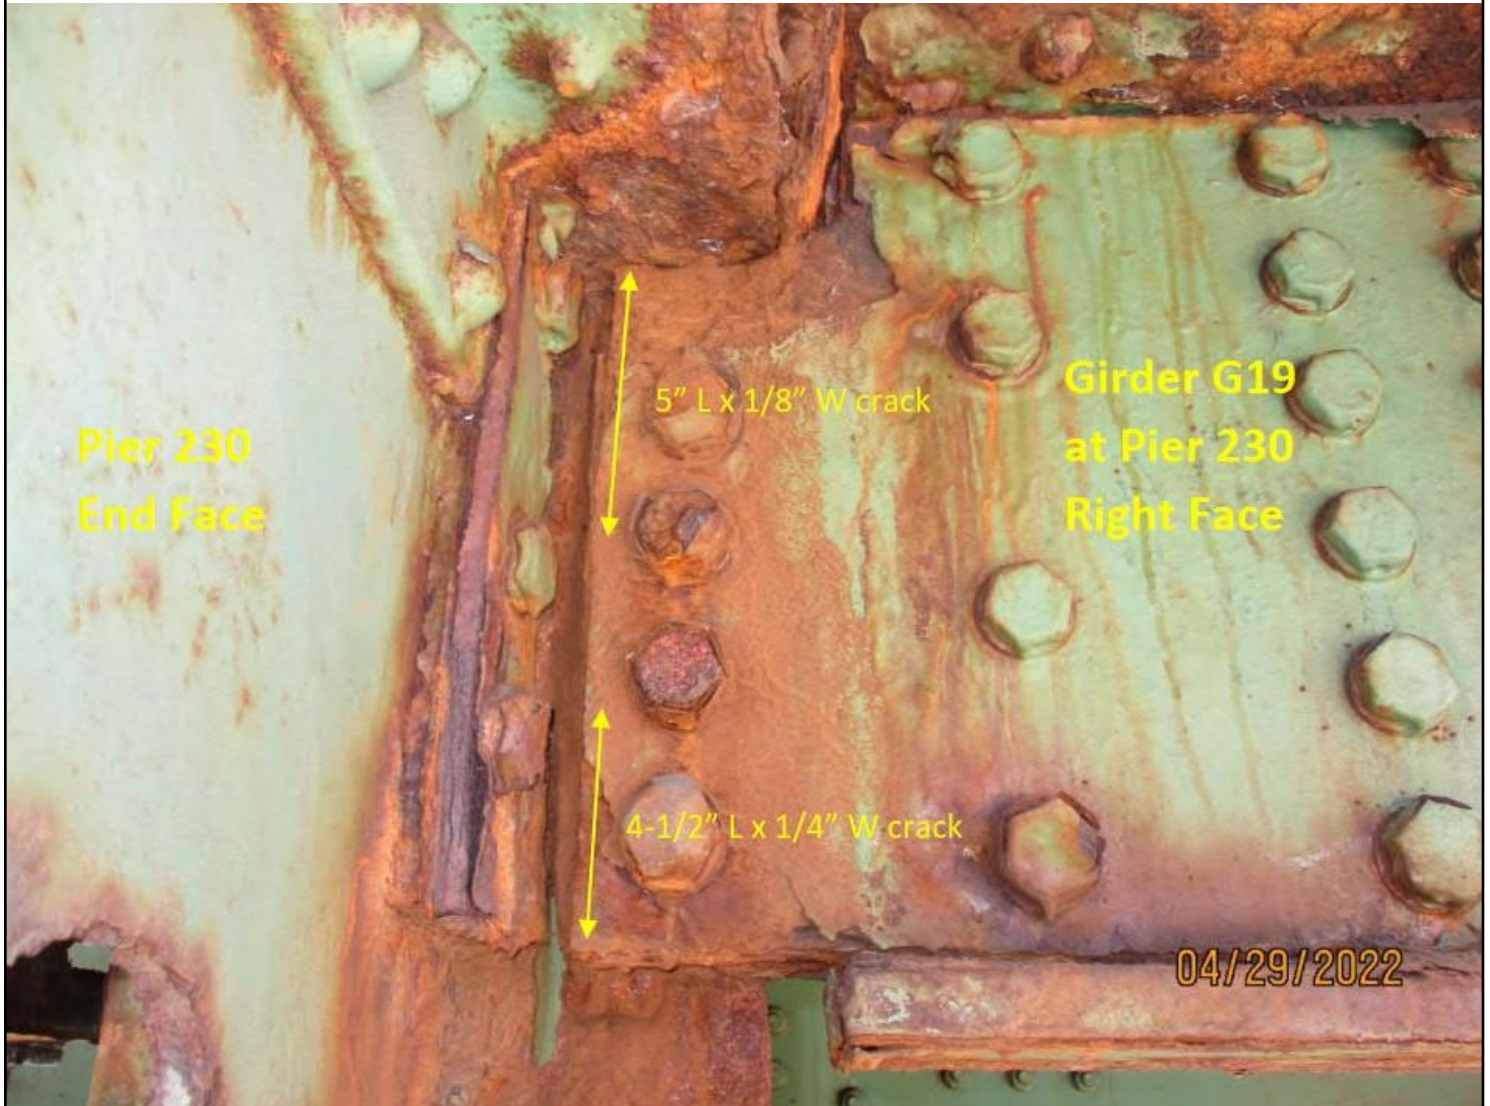
Photo Number: 2

Attachment Description: Photo 2 – Span 231, Girder G19 at Pier 230. General view of defect locations. Looking Left.

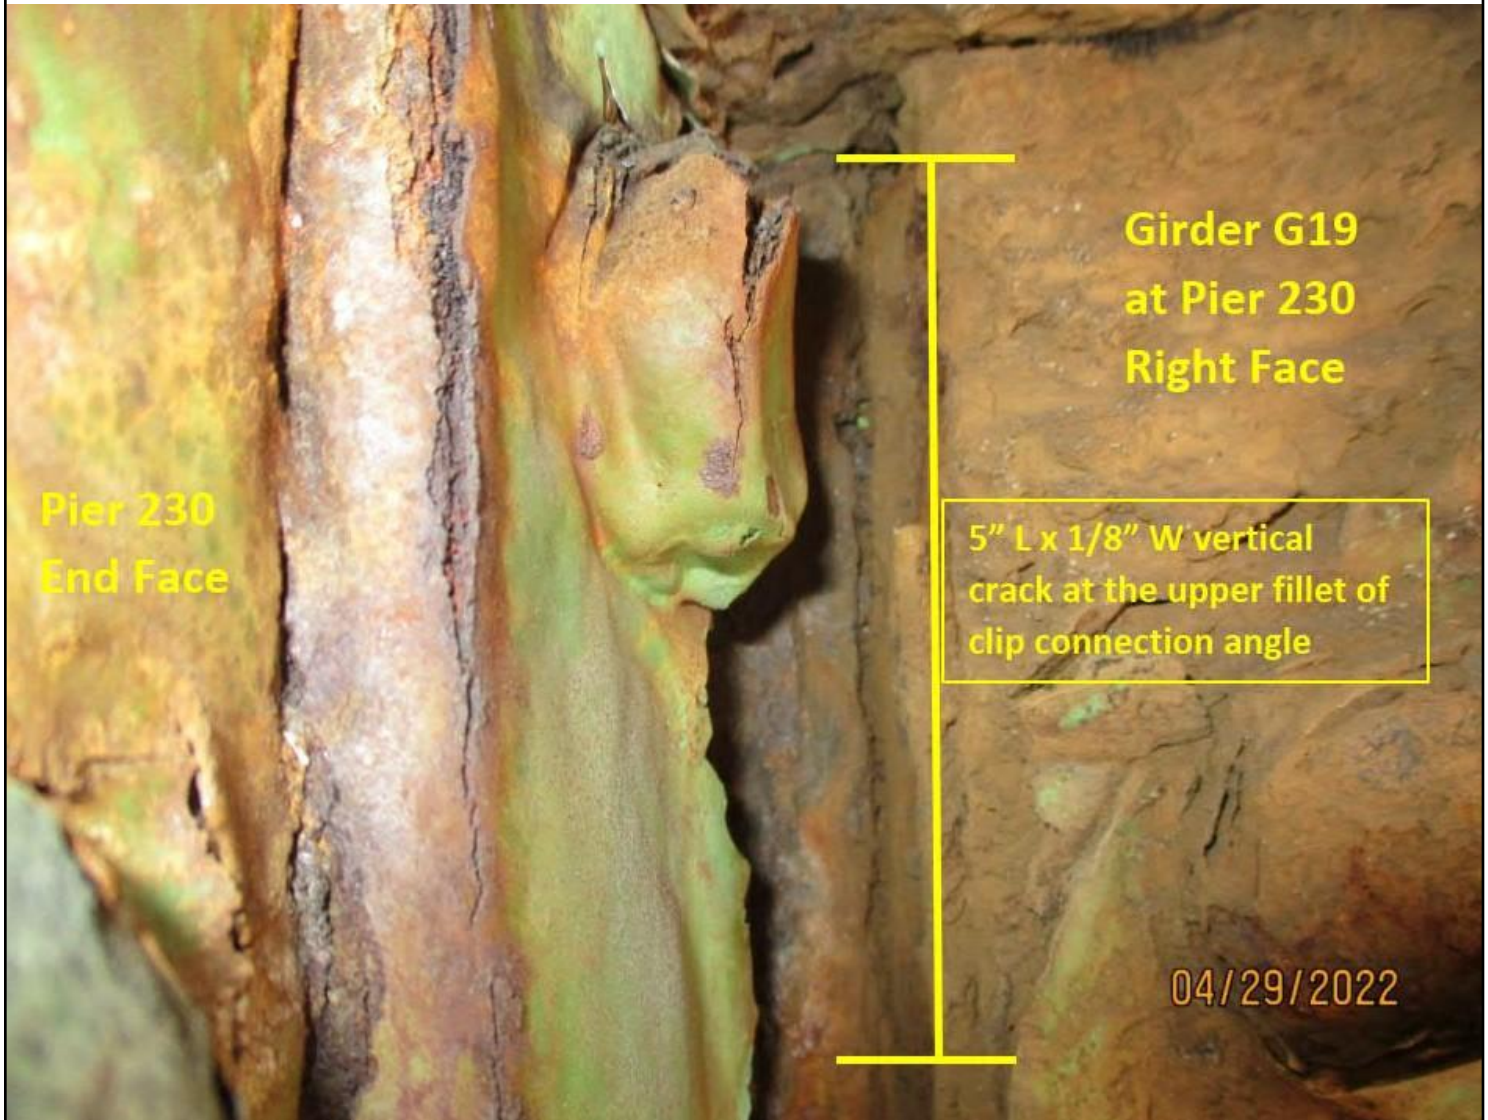
Photo Number: 3

Attachment Description: Photo 3 – Span 231, Girder G19 at Pier 230. Close-up view of showing a 5" long x 1/8" wide vertical crack at the upper fillet of right clip connection angle. Looking Left.

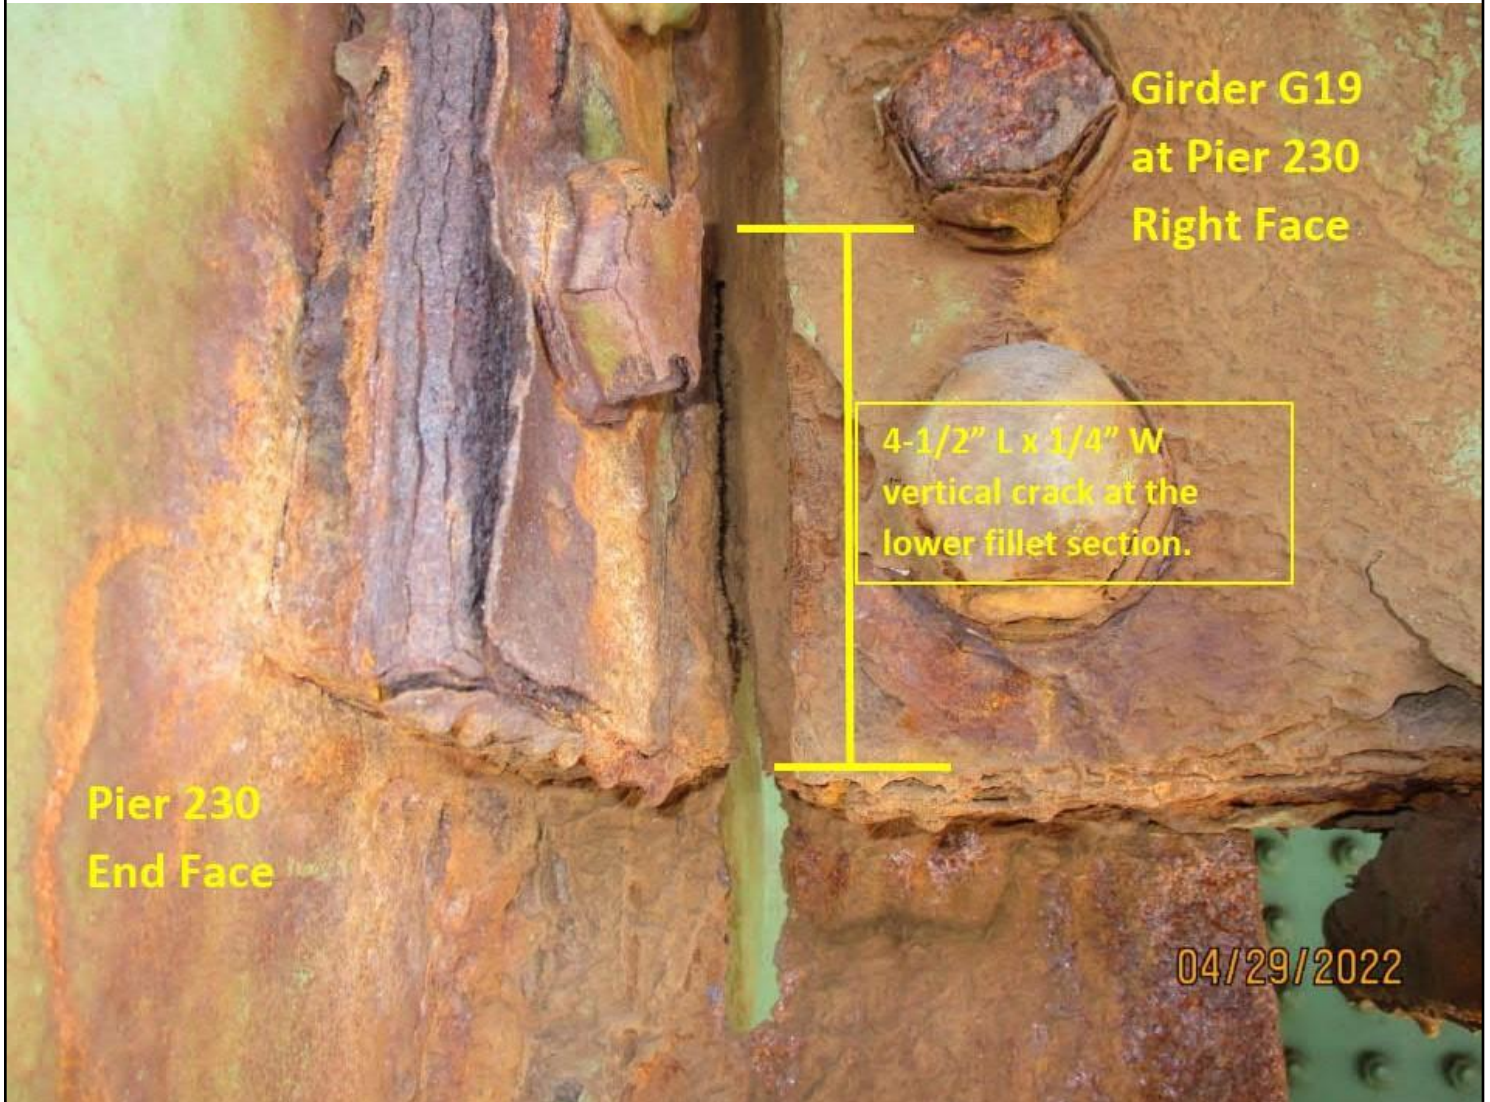
Photo Number: 4

Attachment Description: Photo 4 – Span 231, Girder G19 at Pier 230. Close-up view of the flagged location showing a 4-1/2" long vertical crack x 1/4" wide at the lower fillet section. Looking Left.

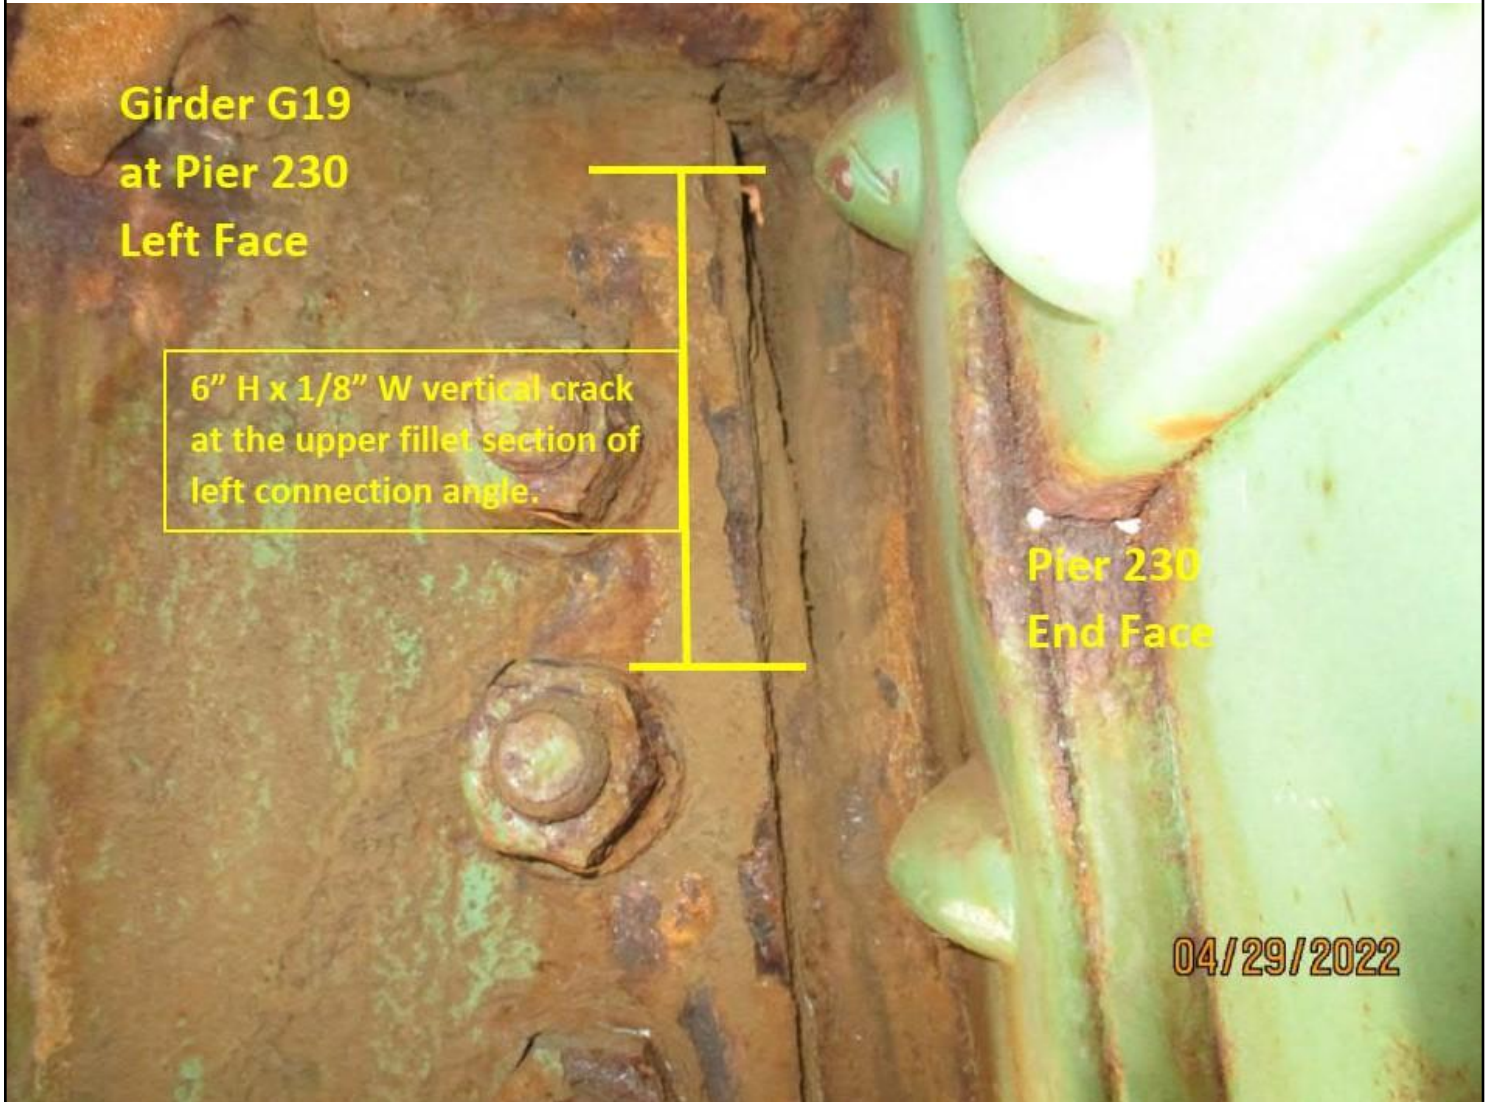
Photo Number: 5

Attachment Description: Photo 5 – Span 231, Girder G19 at Pier 230. Close-up view of 6" long x 1/8" wide vertical crack at the upper fillet section of left connection angle. Looking Right.

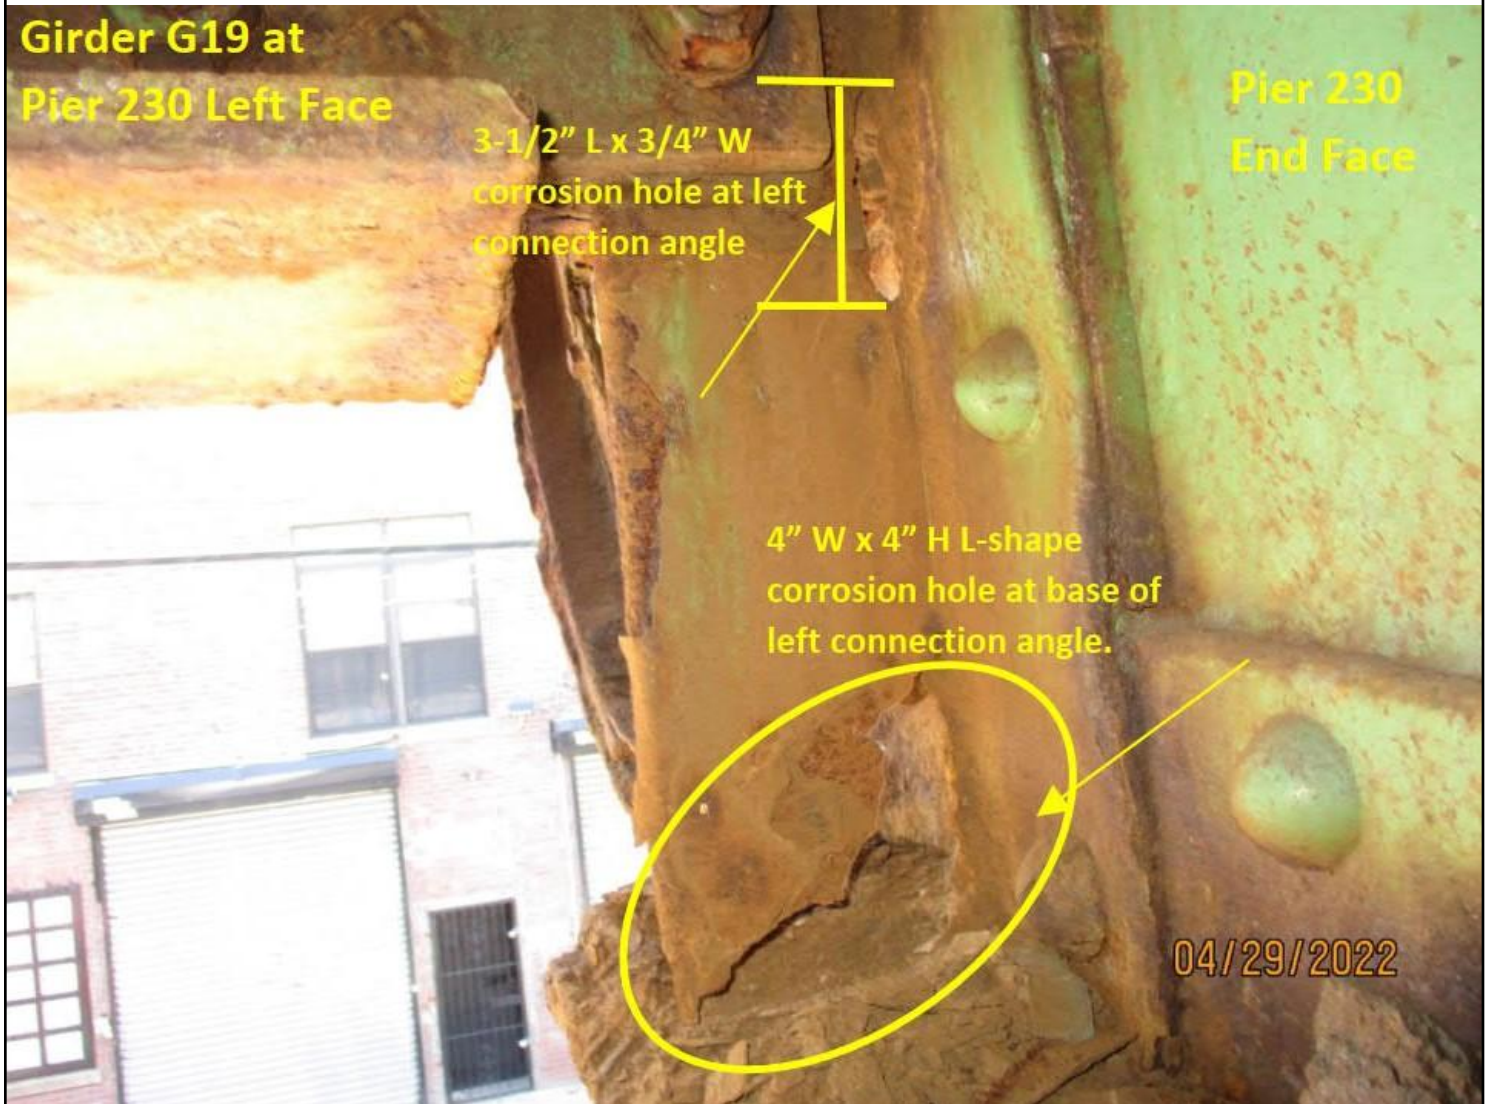
Photo Number: 6

Attachment Description: Photo 6 – Span 231, Girder G19 at Pier 230. Close-up view of 3-1/2" long x 1/4" wide corrosion hole below web of G19 and 4" L x 4" H L-shape corrosion hole at the base of left stiffener connection angle. Looking Right.

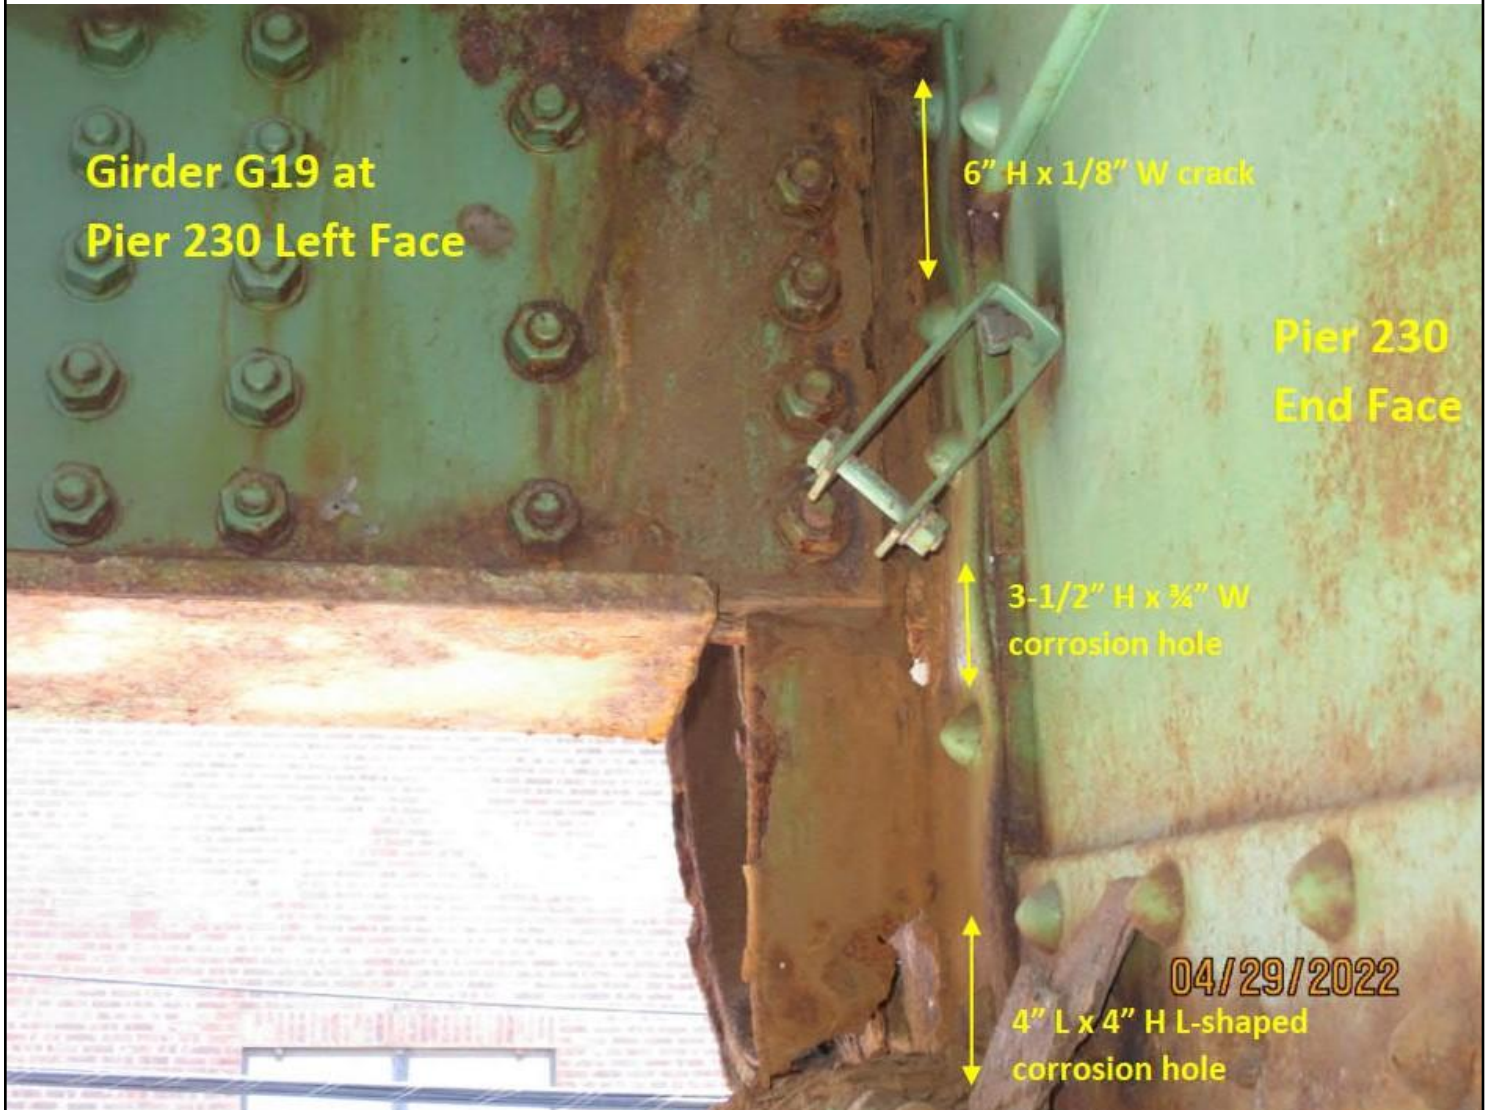
Photo Number: 7

Attachment Description: Photo 7 – Span 231, Girder G19 at Pier 230. General view of defect locations at left side connection angle. Looking Right.

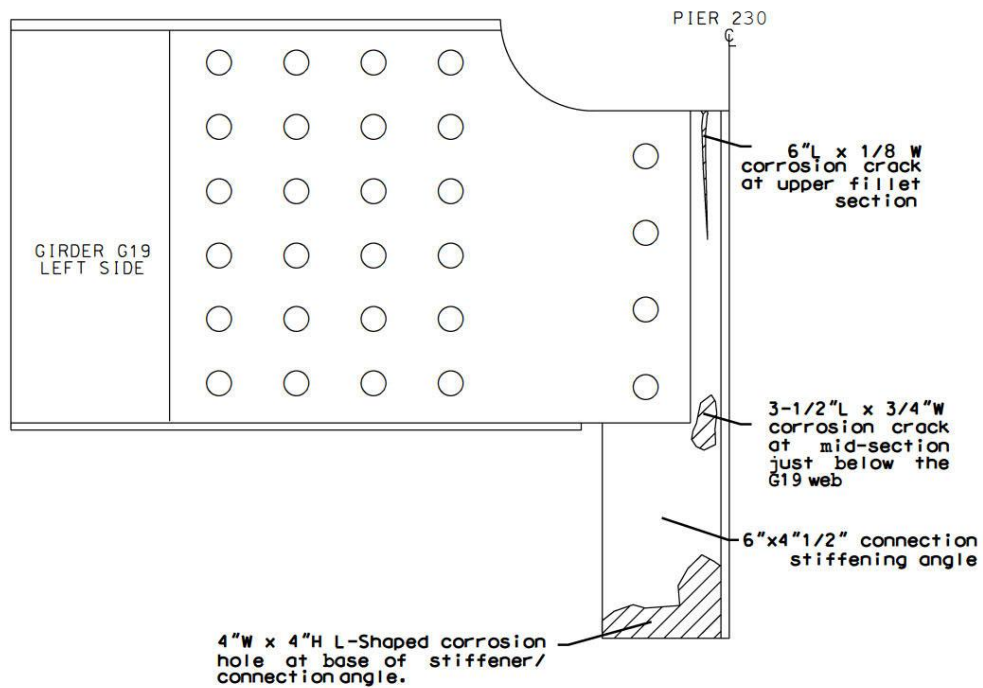
Photo Number: 8

LEFT SIDE OF GIRDER G19 AT PIER 230
SCALE: N.T.S.

Attachment Description: SN 231 G19 at Pier 230 Left Face Sketch

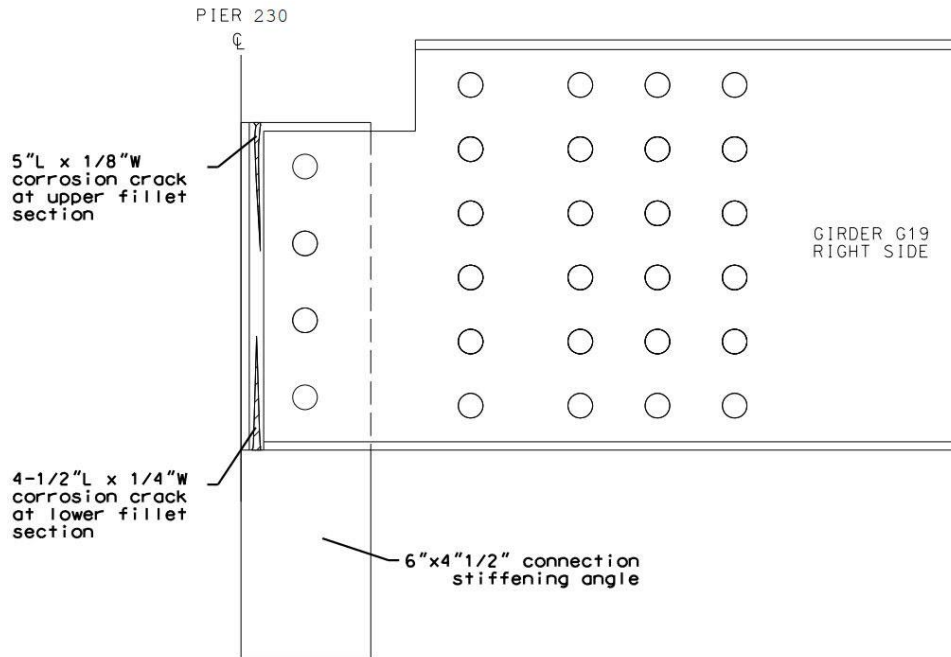
Photo Number: 9

RIGHT SIDE OF GIRDER G19 AT PIER 230
SCALE: N.T.S**Attachment Description: SN 231 G19 at Pier 230 Right Face Sketch**

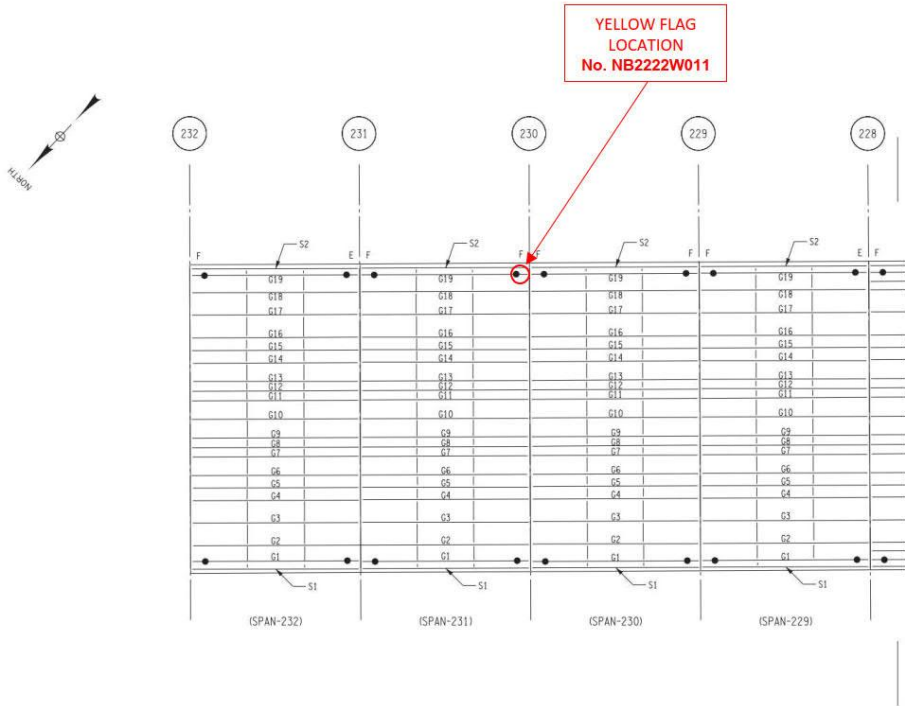
Photo Number: 10 Photo Filename: Span 231 G19 at Pier 230 Framing Plan-edit.jpg

Attachment Description: SN 231 G19 at Pier 230 Framing Plan
